Name Of Dam: WOODSTOCK

Location: SHENANDOAH COUNTY, STATE OF VIRGINIA

Inventory Number: VA 17104

PHASE I INSPECTION REPORT

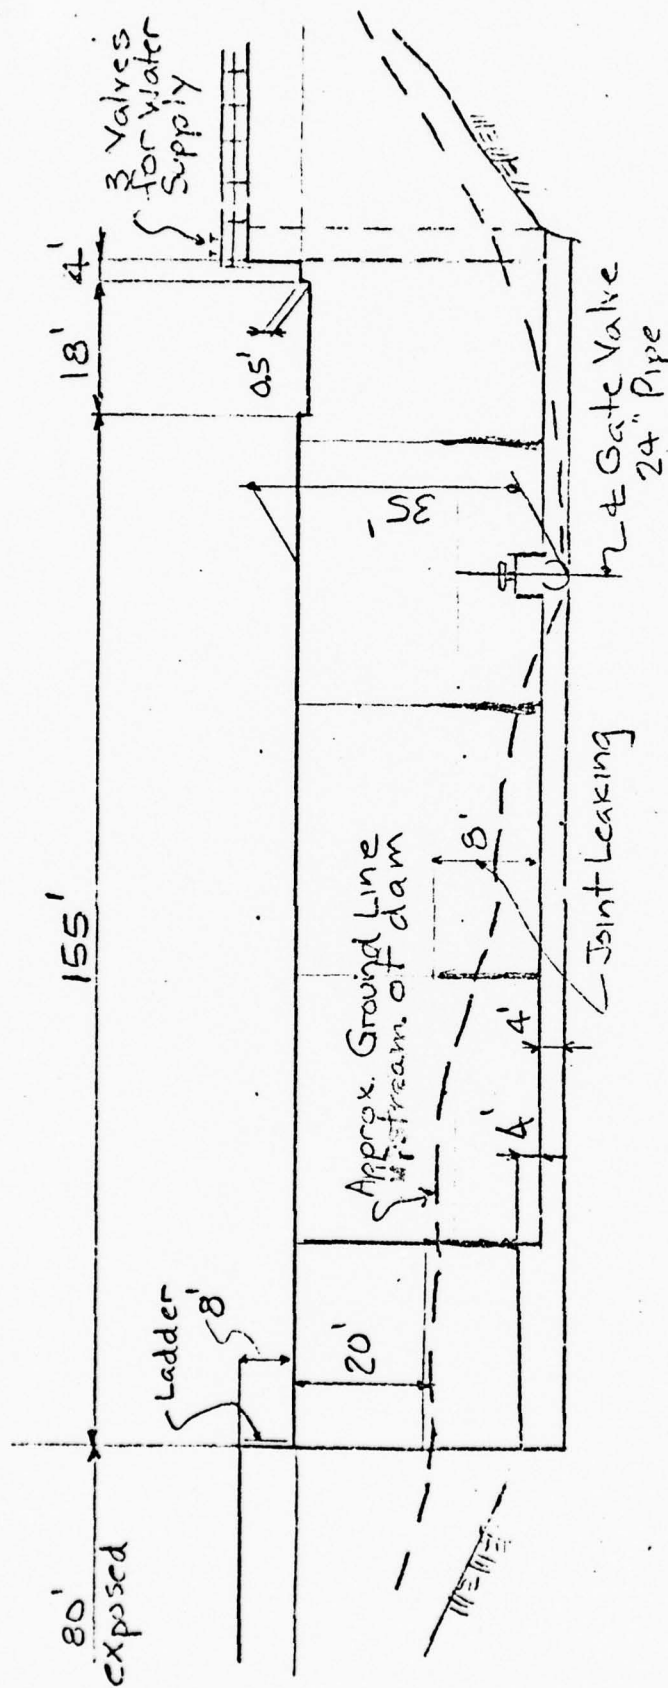
WOODSTOCK - ELEVATION OF DOWNSTREAM FACE
 (AS SKETCHED FROM FIELD MEASUREMENTS)

Plate 4 is a sketch of the measured dimensions of the dam. It shows that the bottom of the spillway is at the same elevation from end to end and does not follow the abutment slopes as indicated on the original plans. It does, however, correspond to the as-built foundation elevations shown on Plate 2.

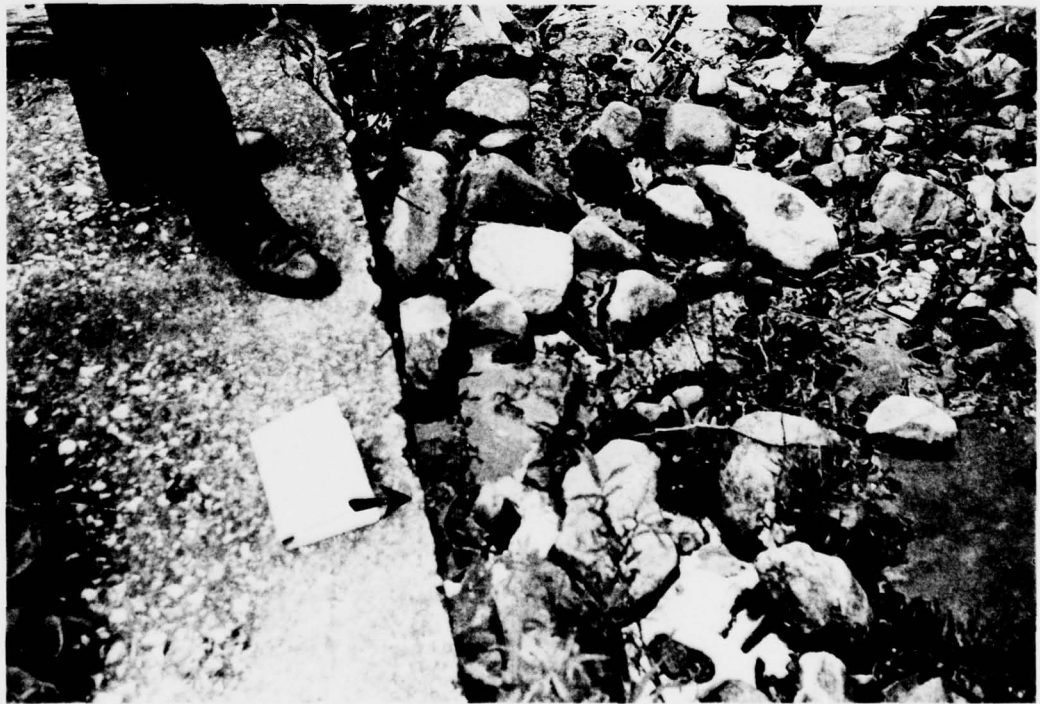
PHOTO 4
Clear Seepage at End of Spillway Bucket

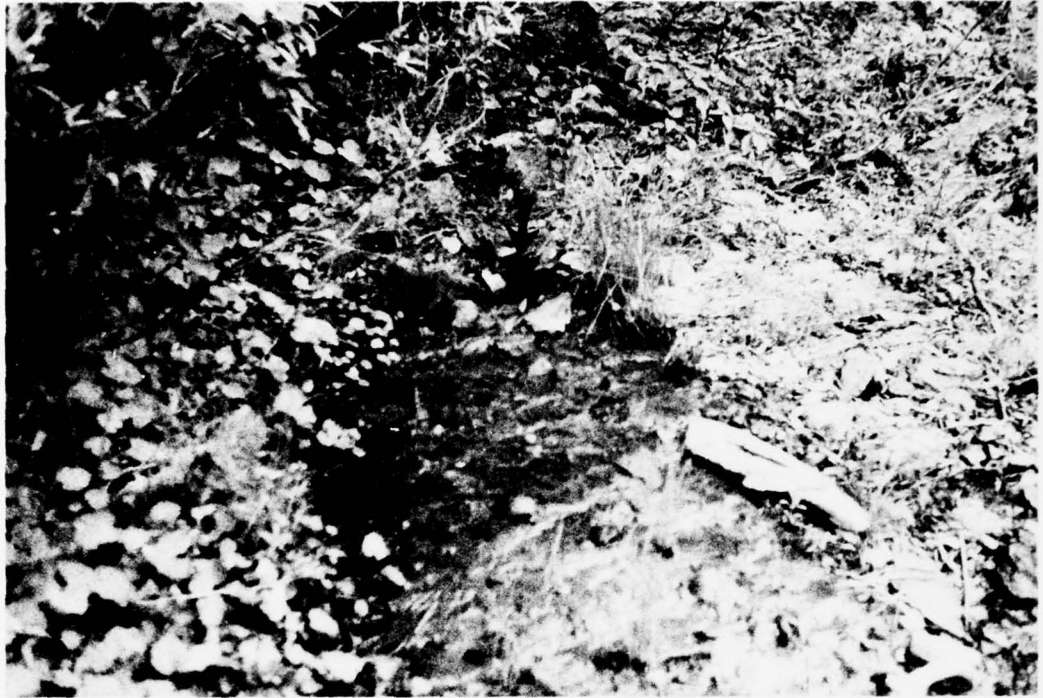
PHOTO 5

Case II was considered because of the clear seepage observed 36 feet downstream of the spillway bucket. Uplift pressure at the toe of the analyzed section was increased proportionally. Case III was the P.M.F. condition with an assumed tailwater elevation of 1225.0 or five feet above the bottom of the spillway. Lack of cross sections and downstream gradients precluded the calculations of tailwater in the Phase I investigation. The tailwater necessary to move the resultant force to the middle one-third of the spillway foundation was calculated to be 13 feet for the P.M.F. case.

Clear Seepage 36' Downstream of Spillway

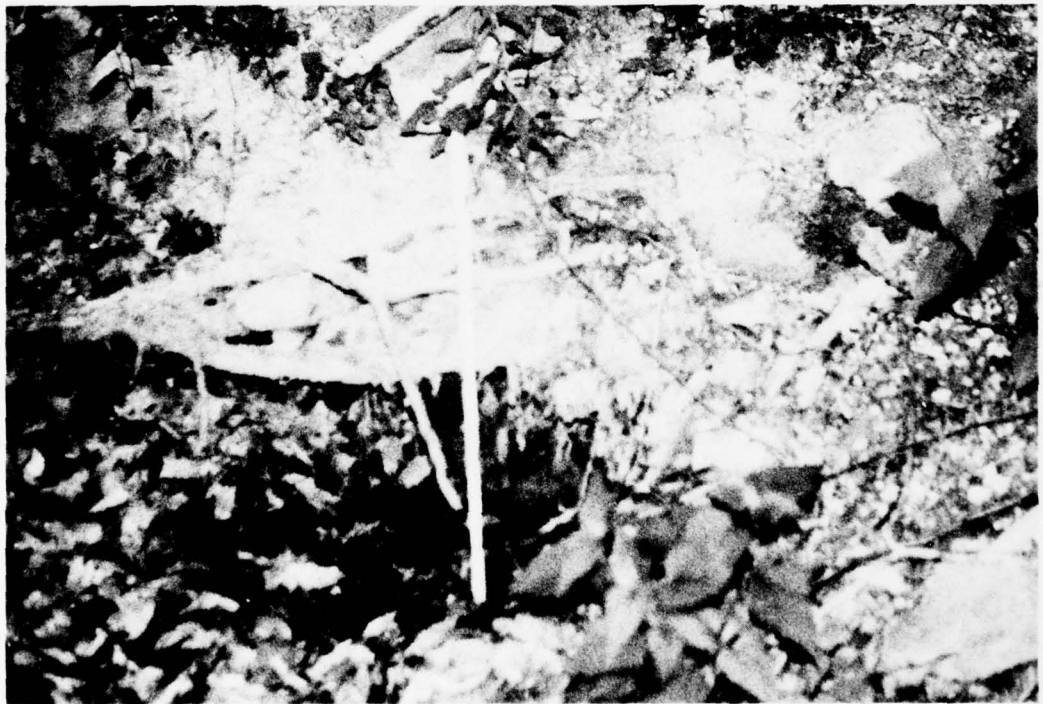
PHOTO 6

- 6) At the toe of the non-overflow section between Stations 2+80 and 2+90¹ (100 g.p.m.). (Photo 6). This area coincides with the location of the 12 inch cast-iron pipe outletting from the intake tower. No serious erosion was observed.

- 3.2.2 Appurtenant Structures: Further investigation is required to determine if the 12 inch outlet pipe is leaking or if the clear seepage at this point originates in the backfill for the pipe.
- 3.2.3 Reservoir Area: Does not require further investigation.
- 3.2.4 Downstream Channel: Does not require further investigation.

Clear Seepage at Toe of Spillway Below Intake Tower (appx. 100 g.p.m.)

- 1) Determination of actual seepage pressures below the dam. This can be obtained with piezometers.
- 2) Determination of the cause of the 100 g.p.m. clear leak in the left downstream abutment and repair of the leak.
- 3) Further analysis should be made of the marginal calculated stability of the spillway. This includes a determination of the tailwater elevation during the P.M.F.
- 4) Patching the clear leak in the intake tower above the highest slide gate by maintenance personnel during the next scheduled maintenance visit. No remedial treatment of the clear leaking vertical joints in the spillway is
